Israel - Implementation of monitoring - common indicators 15, 16 and 25

Meeting of the CORMON on Coast and Hydrography Rome, Italy, 21-22 May 2019

Maayan Haim, Coastal Environment Engineer, Marine Environment Protection Division Israel Ministry of Environmental Protection

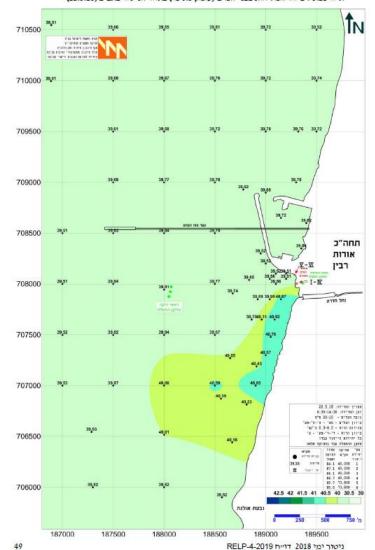
Common Indicator 15 – Example – Hadera desalination Plant – salinity spatial distribution

- One parameter, well defined, easy to measure at any depth
- Distribution of concentration (measurable and objective), not impact
- "Direct impact" on habitats is impractical to measure as opposed to "subjected"
